Insulated lime plaster with cork

Author: Athina Petsou (UCL)

Walls

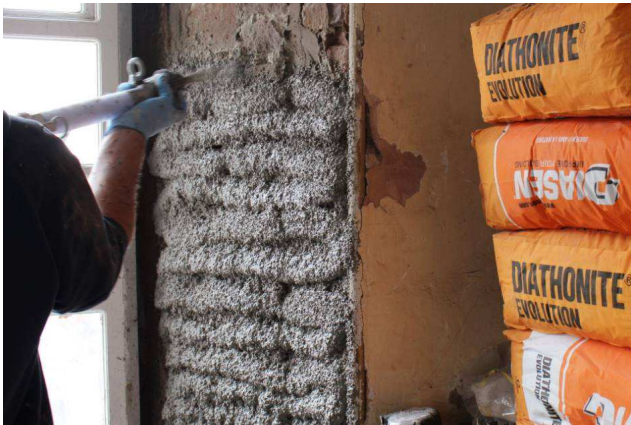
Spray application of insulated lime plaster
© Ecological Building Systems

The solution is capillary active internal wall insulation made of clay, diatomaceous earth, natural hydraulic lime NHL 3.5 and cork. The insulation is supplied in bags, and can be installed to the internal side of the wall as a wet plaster (suitable for the insulation of small areas) or with a spray equipment. For this solution, a finer wet plaster is the interior finish.

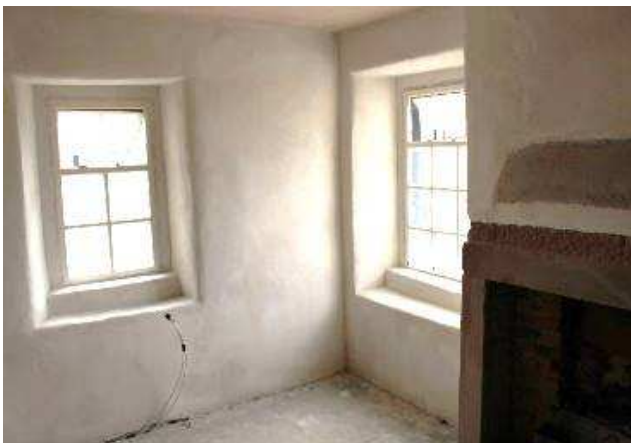
Insulated wall (lime plaster and cork) ©
Ecological Building Systems

The aim of the solution is to improve the thermal resistance of a wall. It allows to retain the external appearance of the wall and preserving the external façade, as it is applied to the internal wall. In some historic buildings, there is a reduced extent of rainwater protection, allowing rainwater penetration and moisture accumulation within the wall. In this solution, the risk of moisture accumulation is reduced because the insulation is vapour open and capillary active, allowing the drying of excess moisture.
